Construction Issues

Alabama Seminar
2013

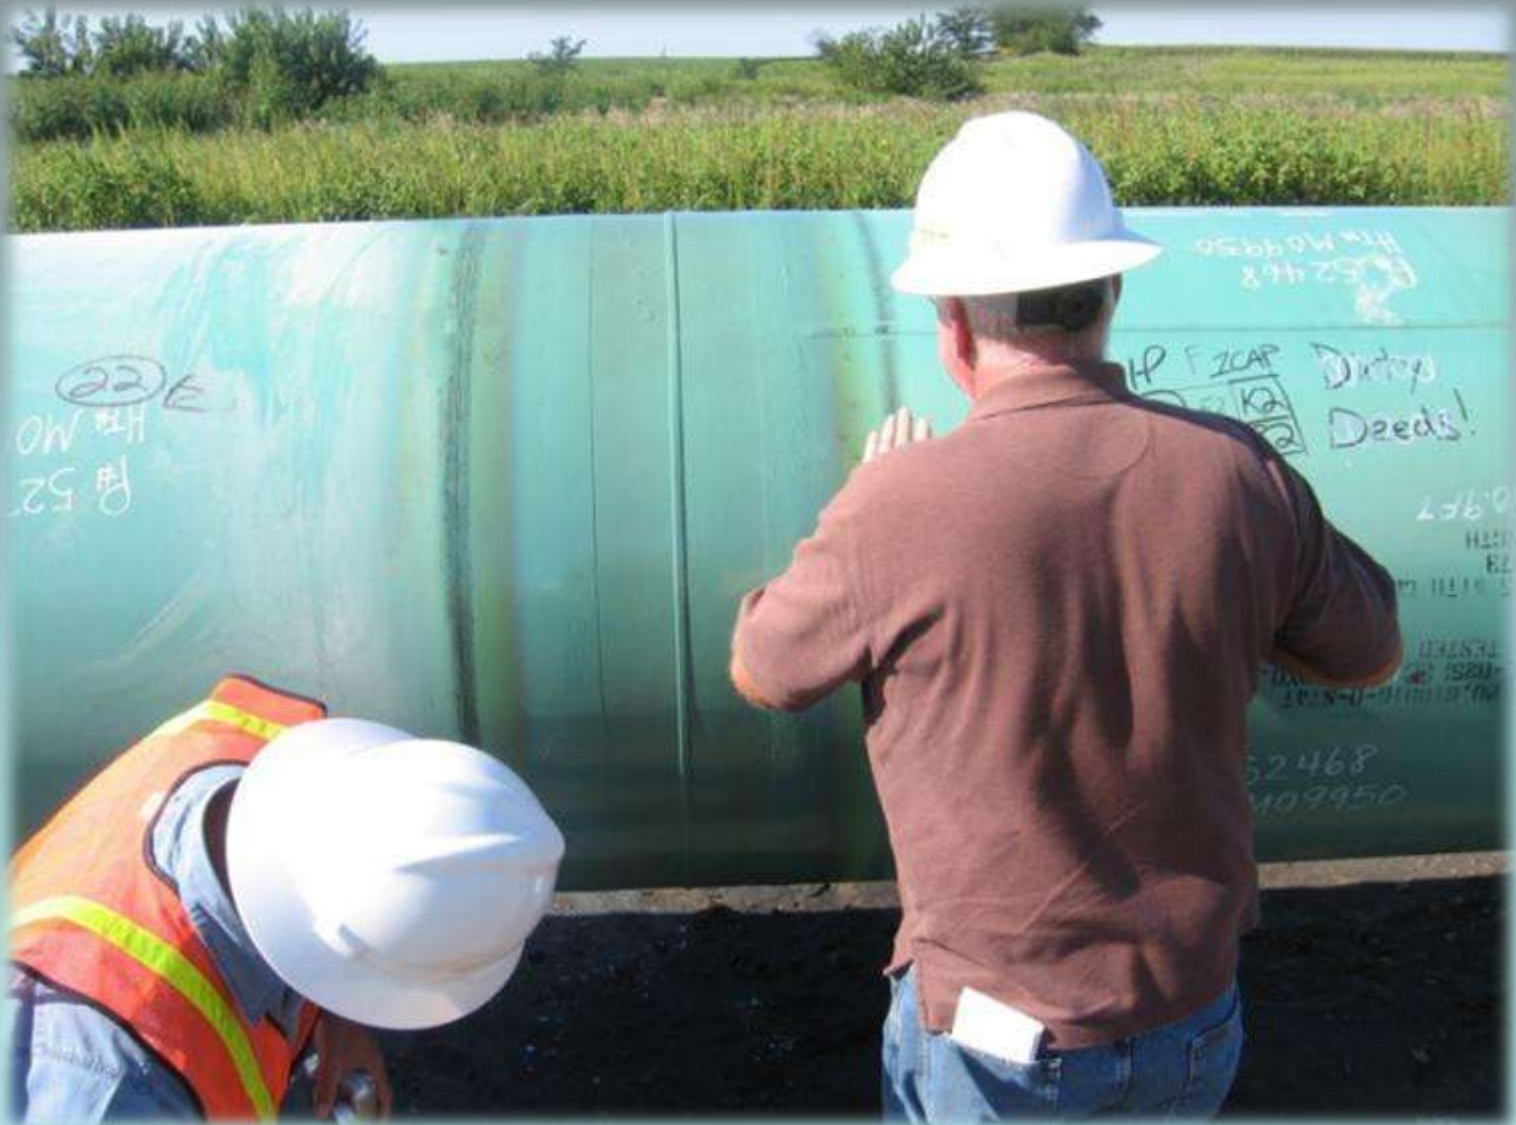
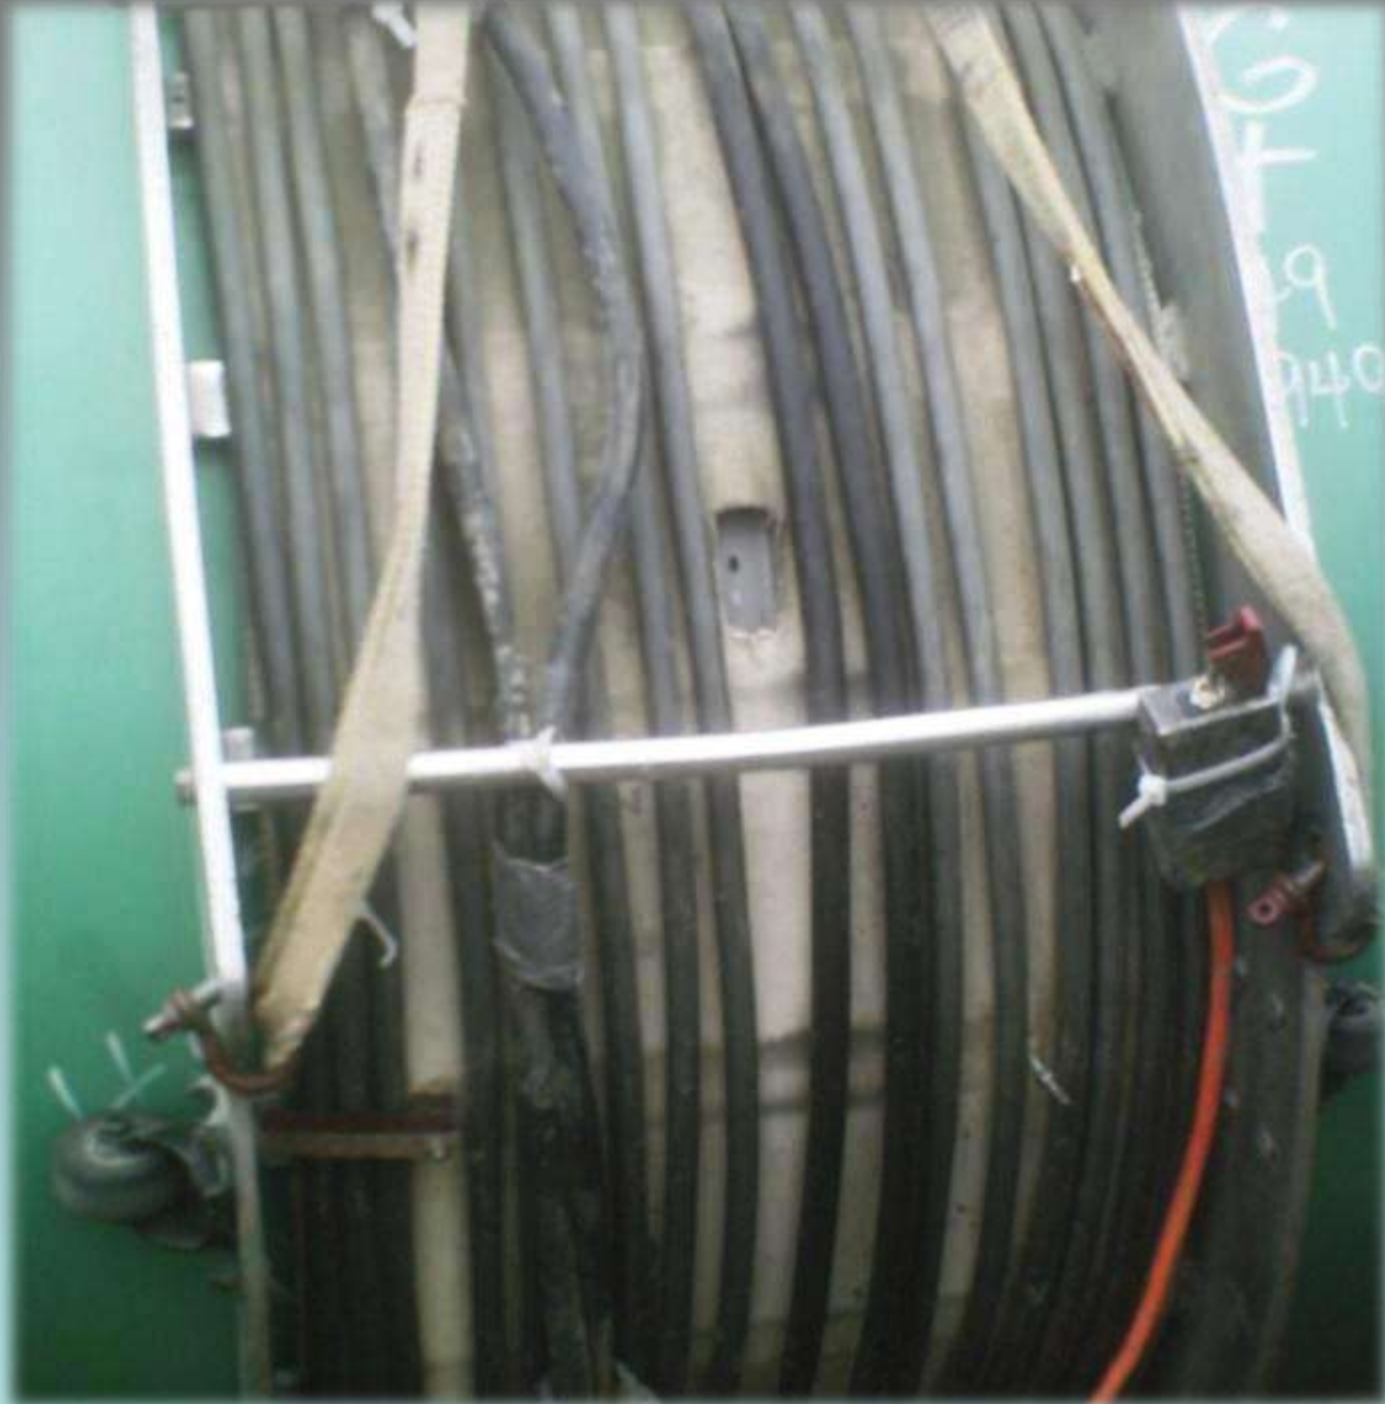
- Insufficient heating (3M procedure specify 425 – 488 degrees F - lower temperatures could mean improper curing)
- Over heating during application can be a problem (the coating looks burnt and is unacceptable)
- Poor sandblasting

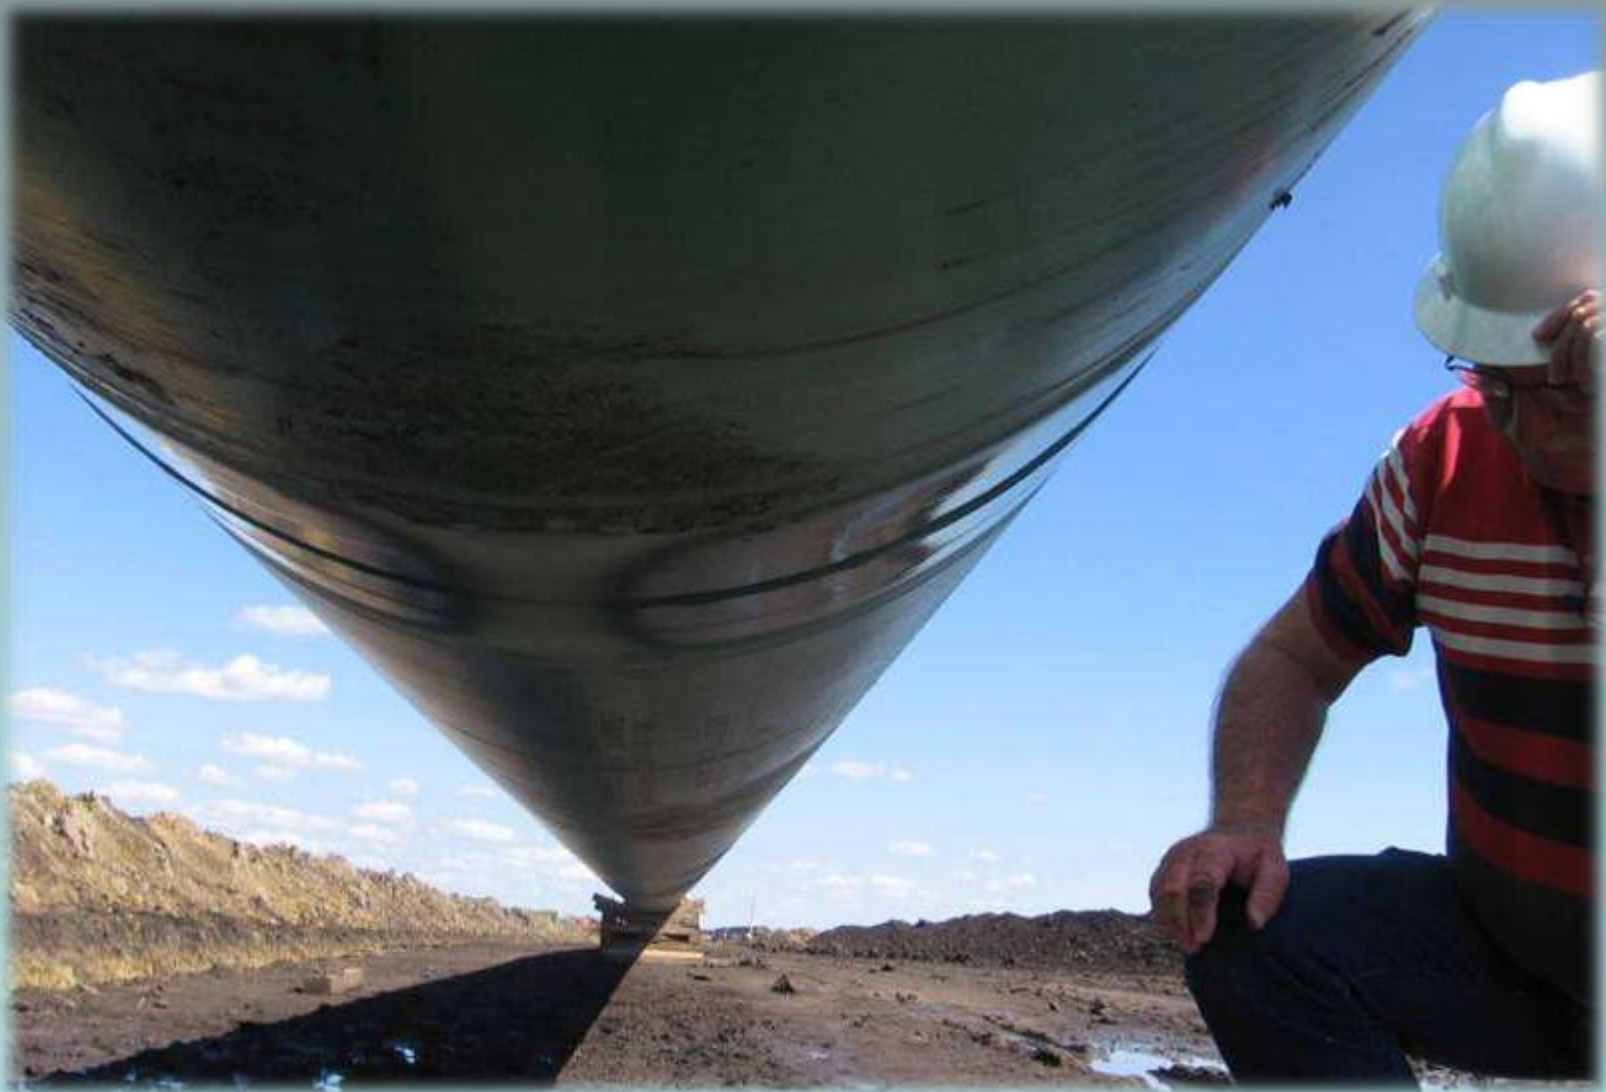
Is there water in the pipe? = no
coating coverage

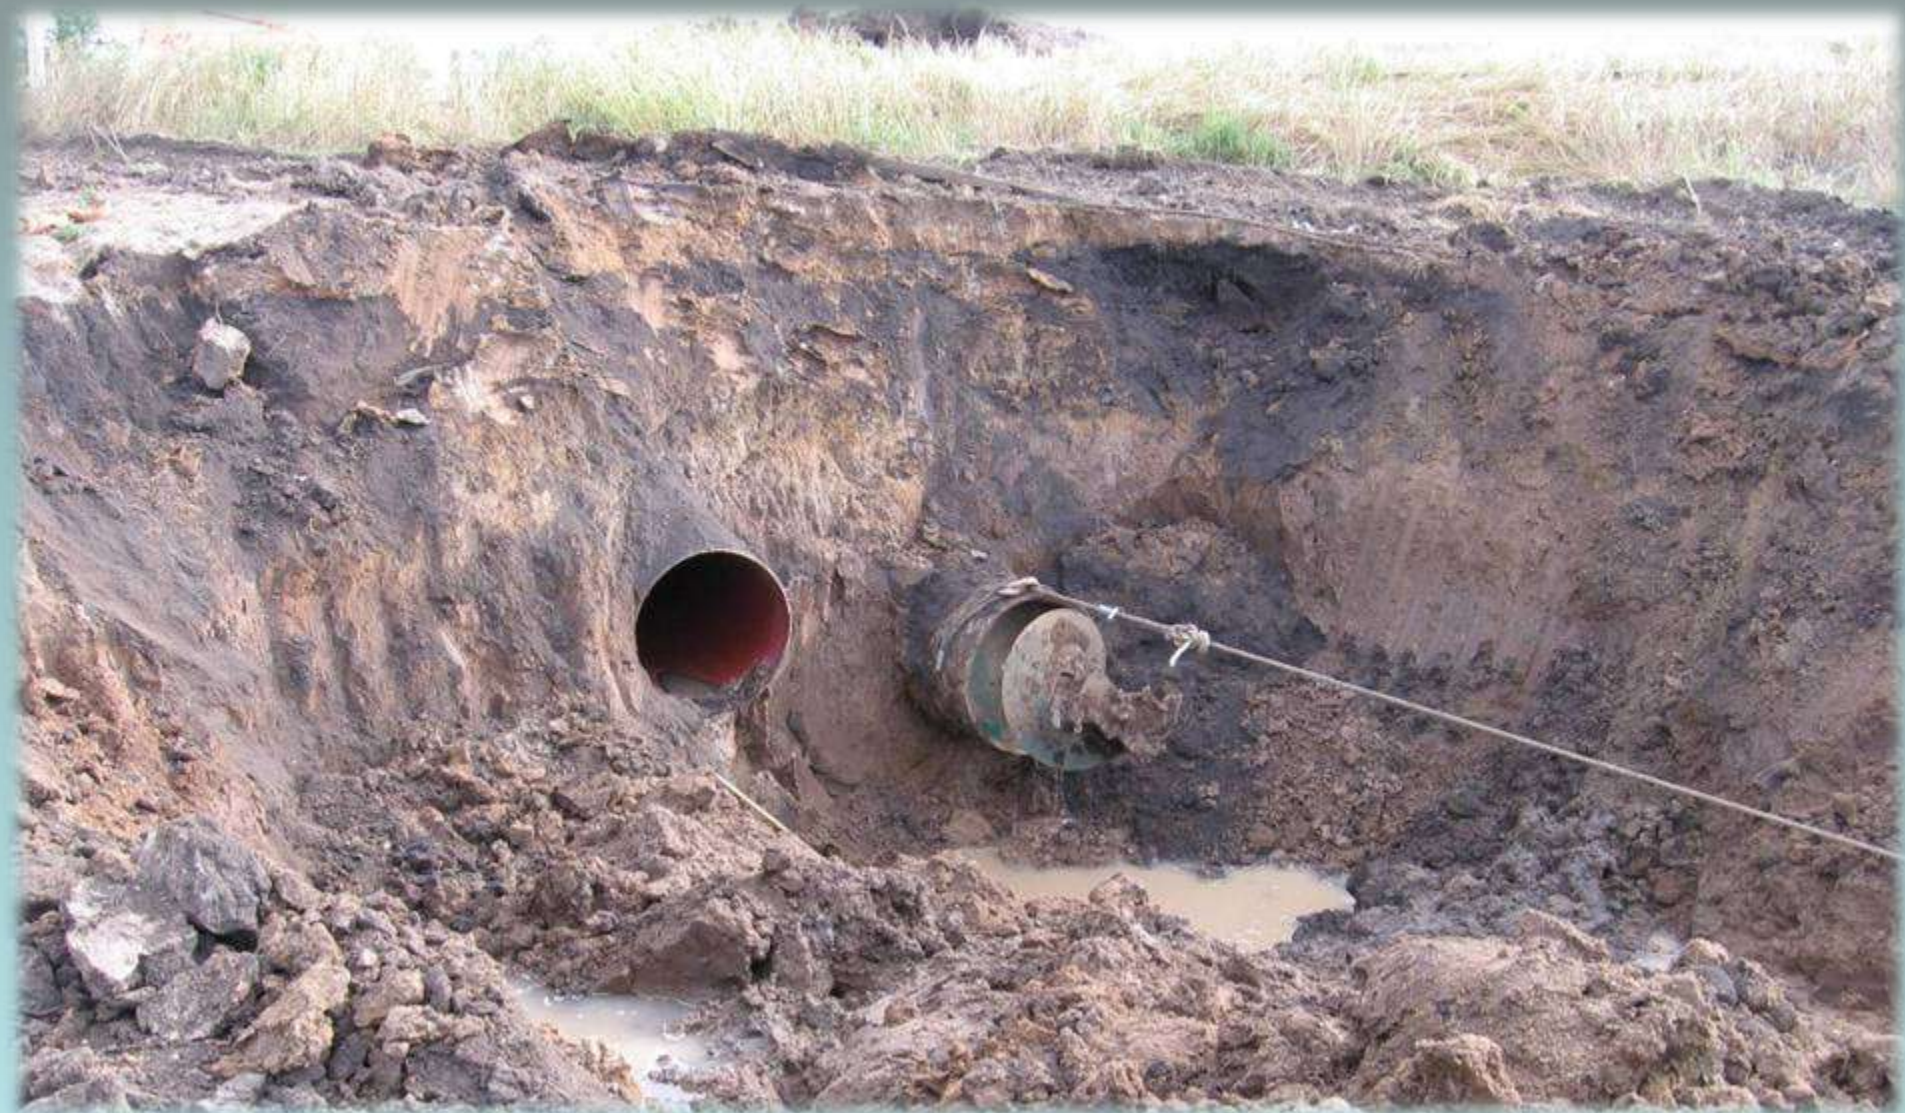
Proper burial depth on bores?

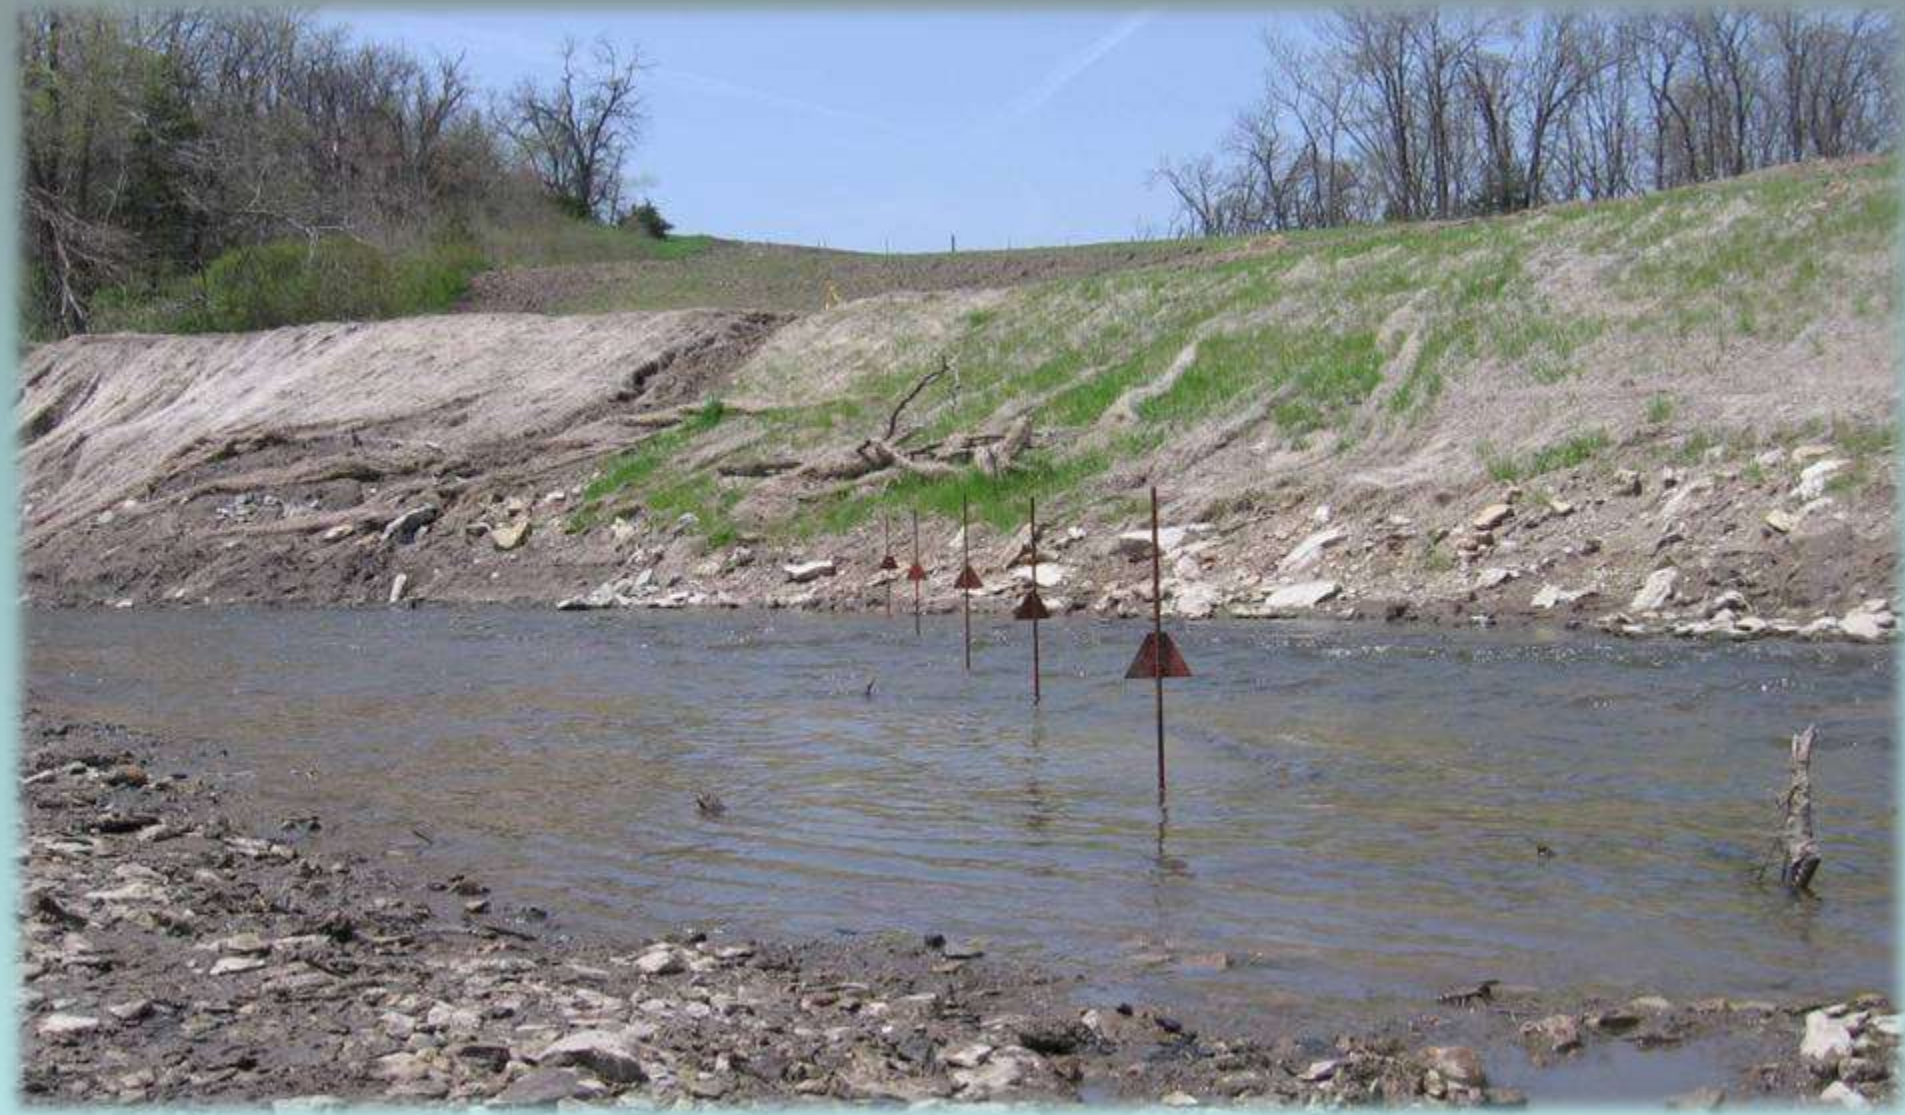
Is the pipeline buried deep enough
and protected from erosion?

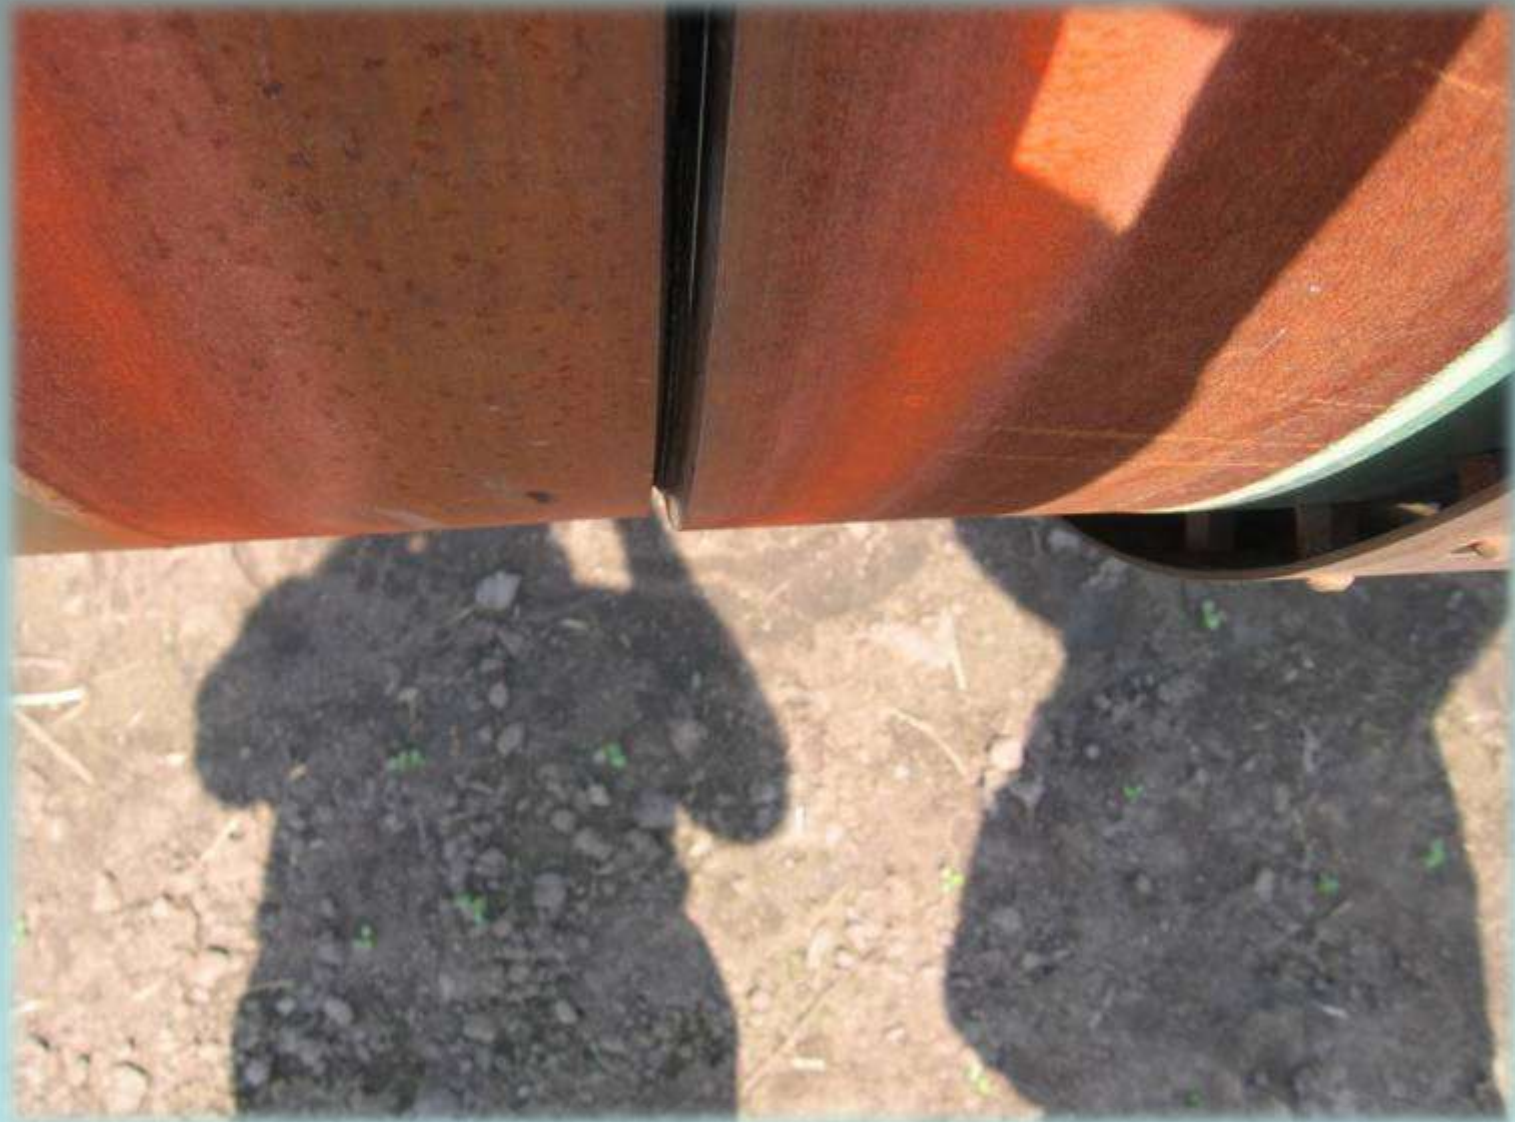
The welding procedure allows how much high-low?

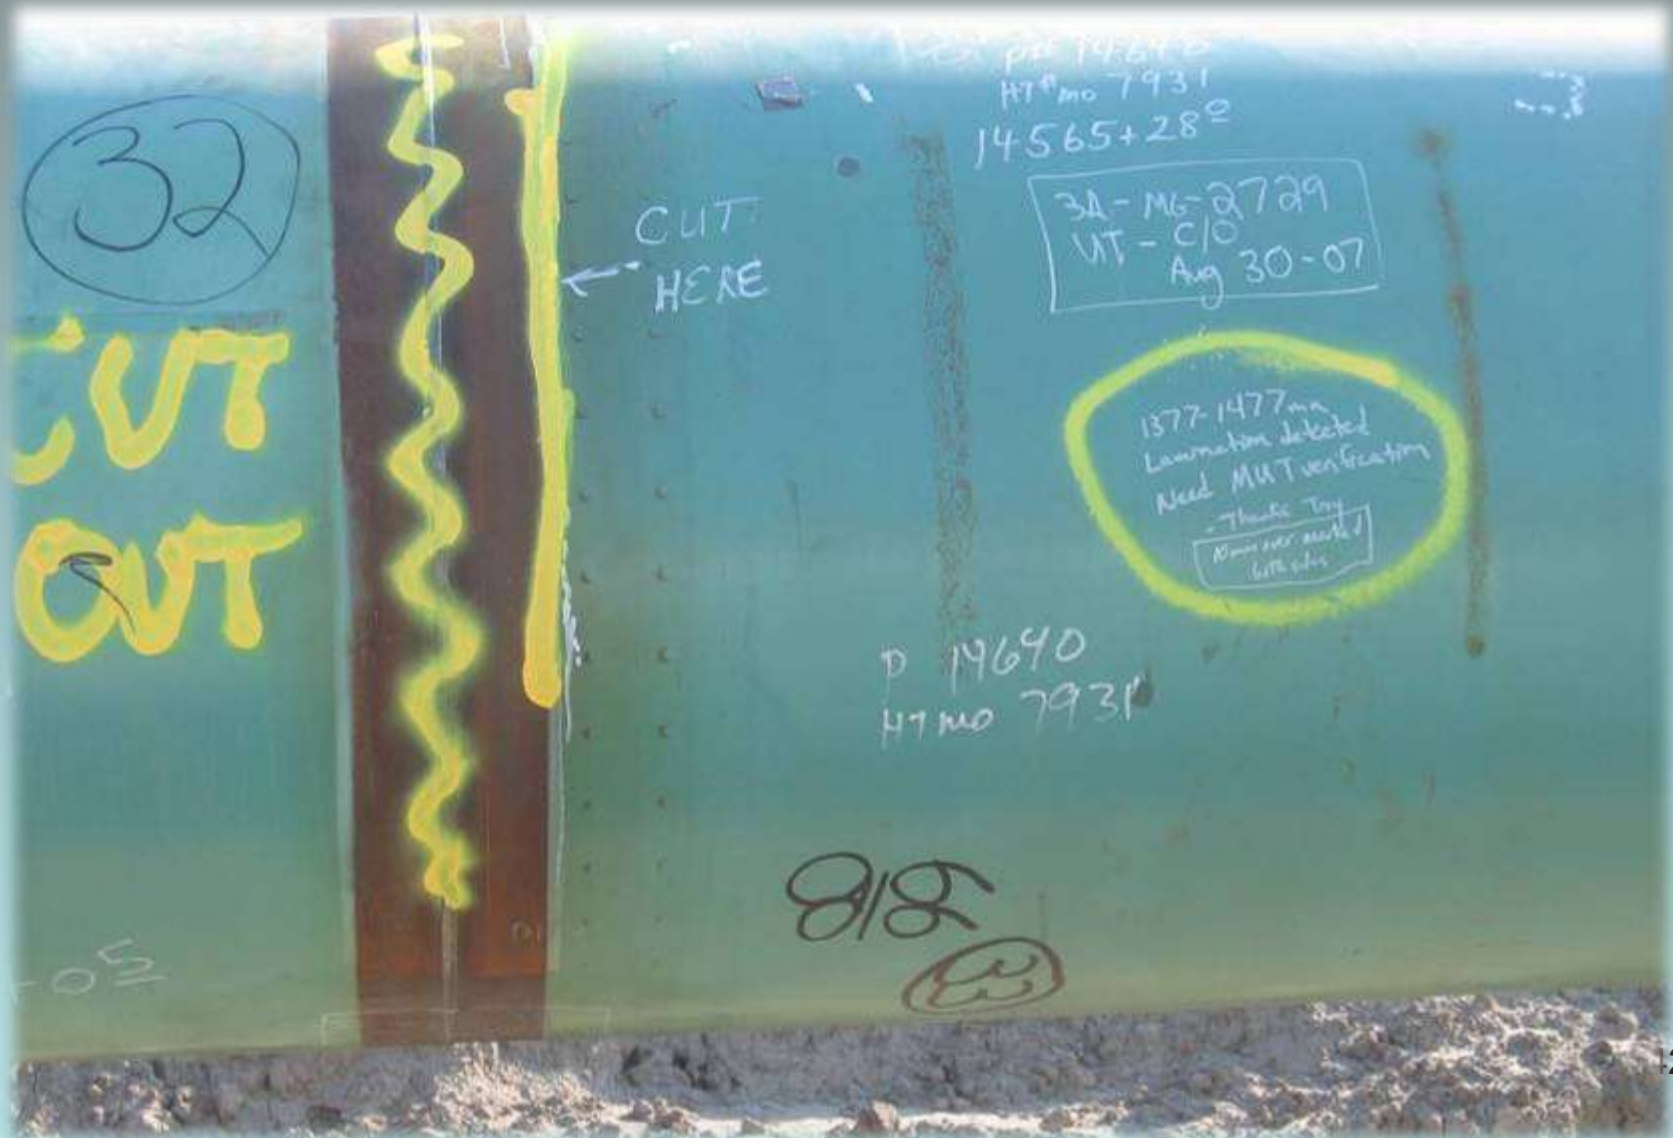
Laminations can be an issue especially associated with an 80% waiver

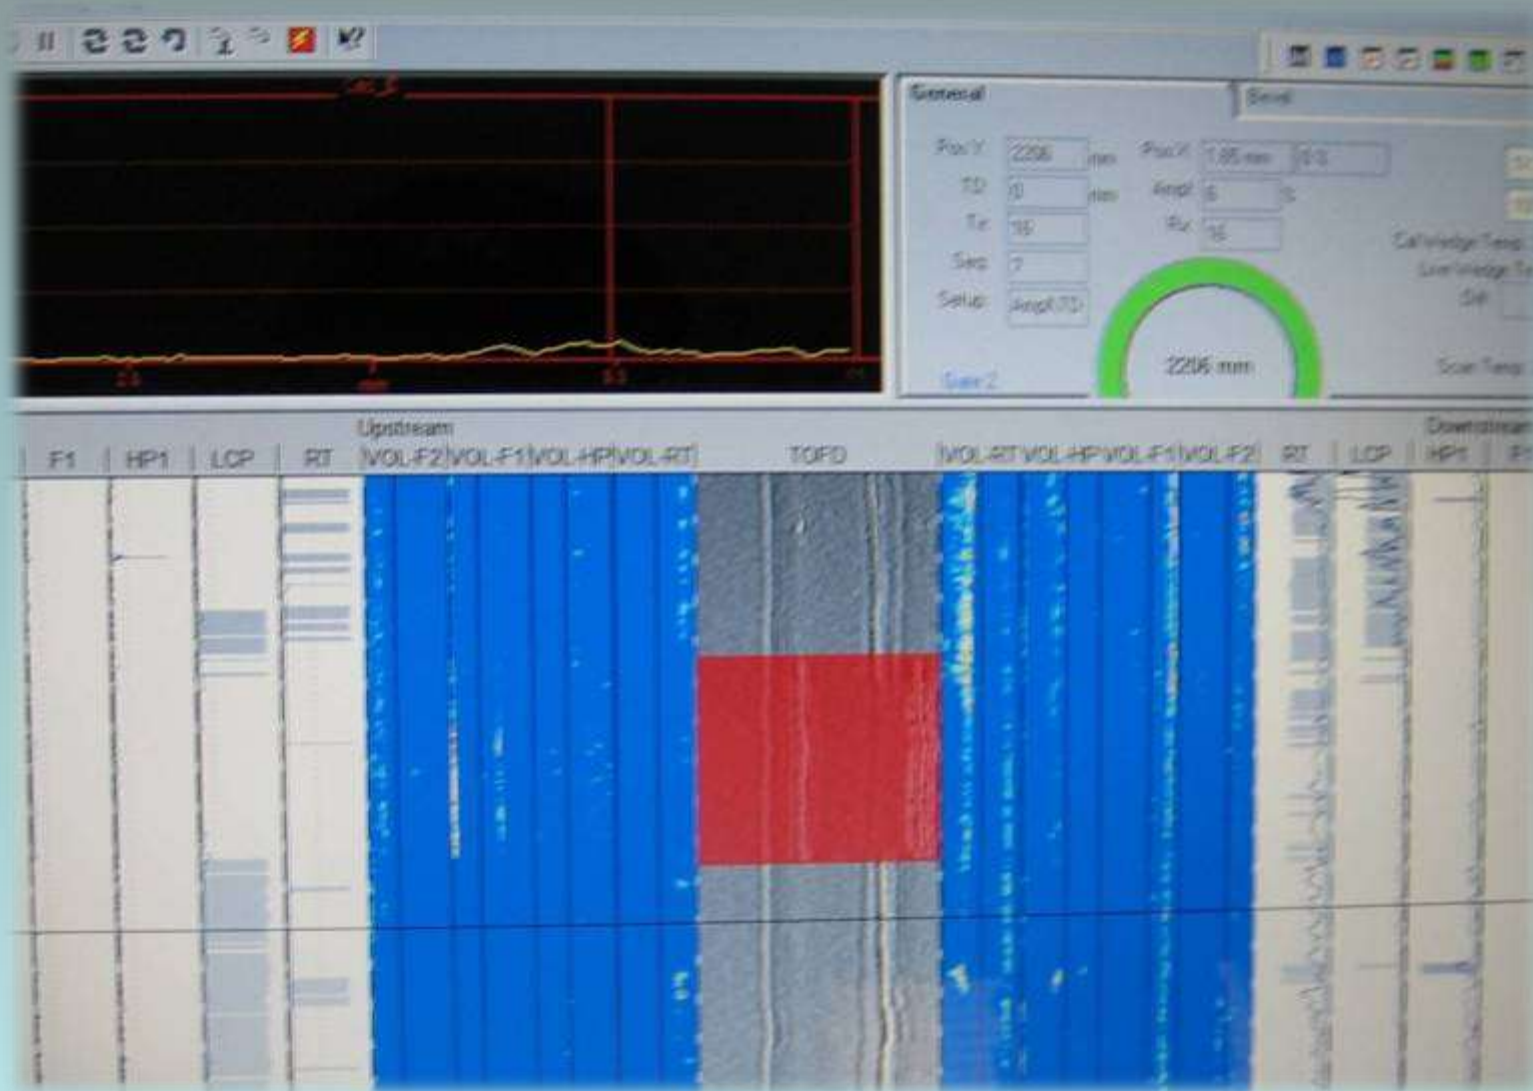
AUT easily shows laminations

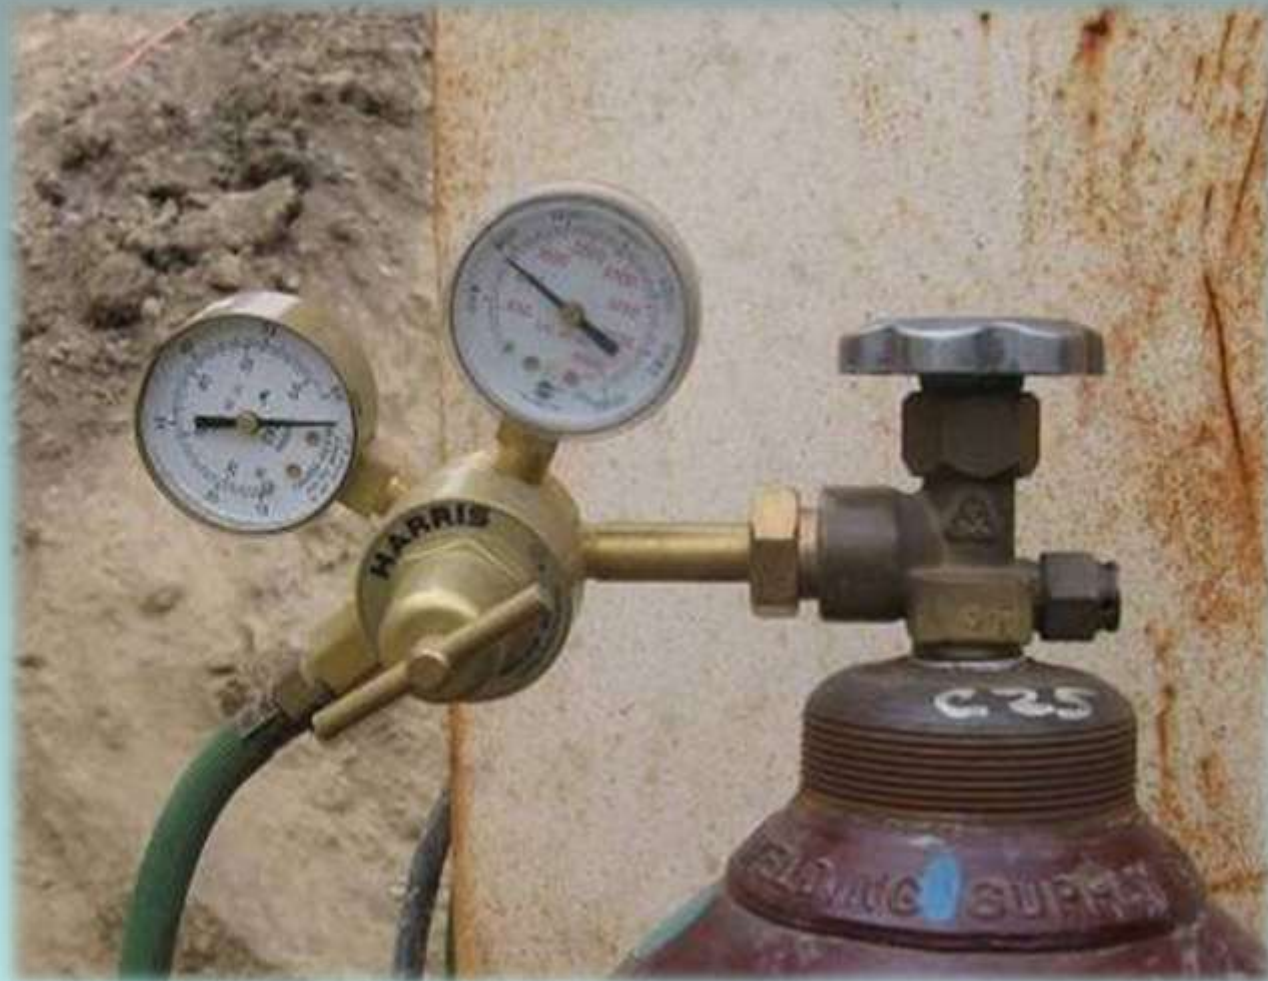
The procedure states 20 – 40 cfh shielding gas flow rate. Does the photo show an acceptable value?
(No)

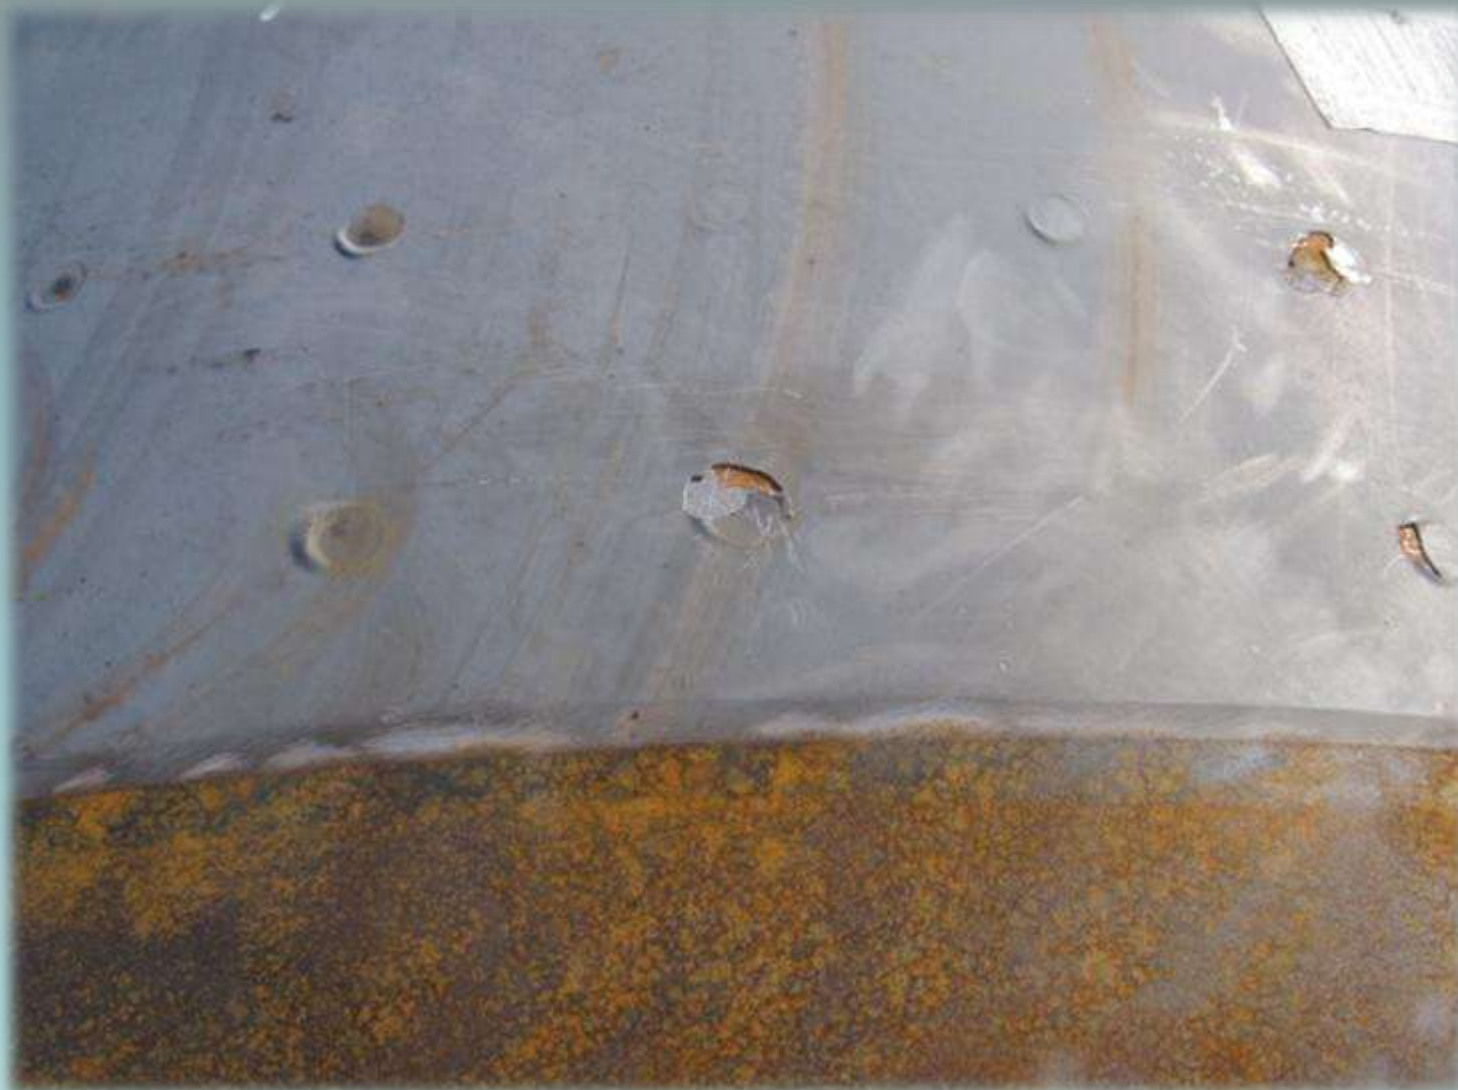
Welding Band Damage to Coating

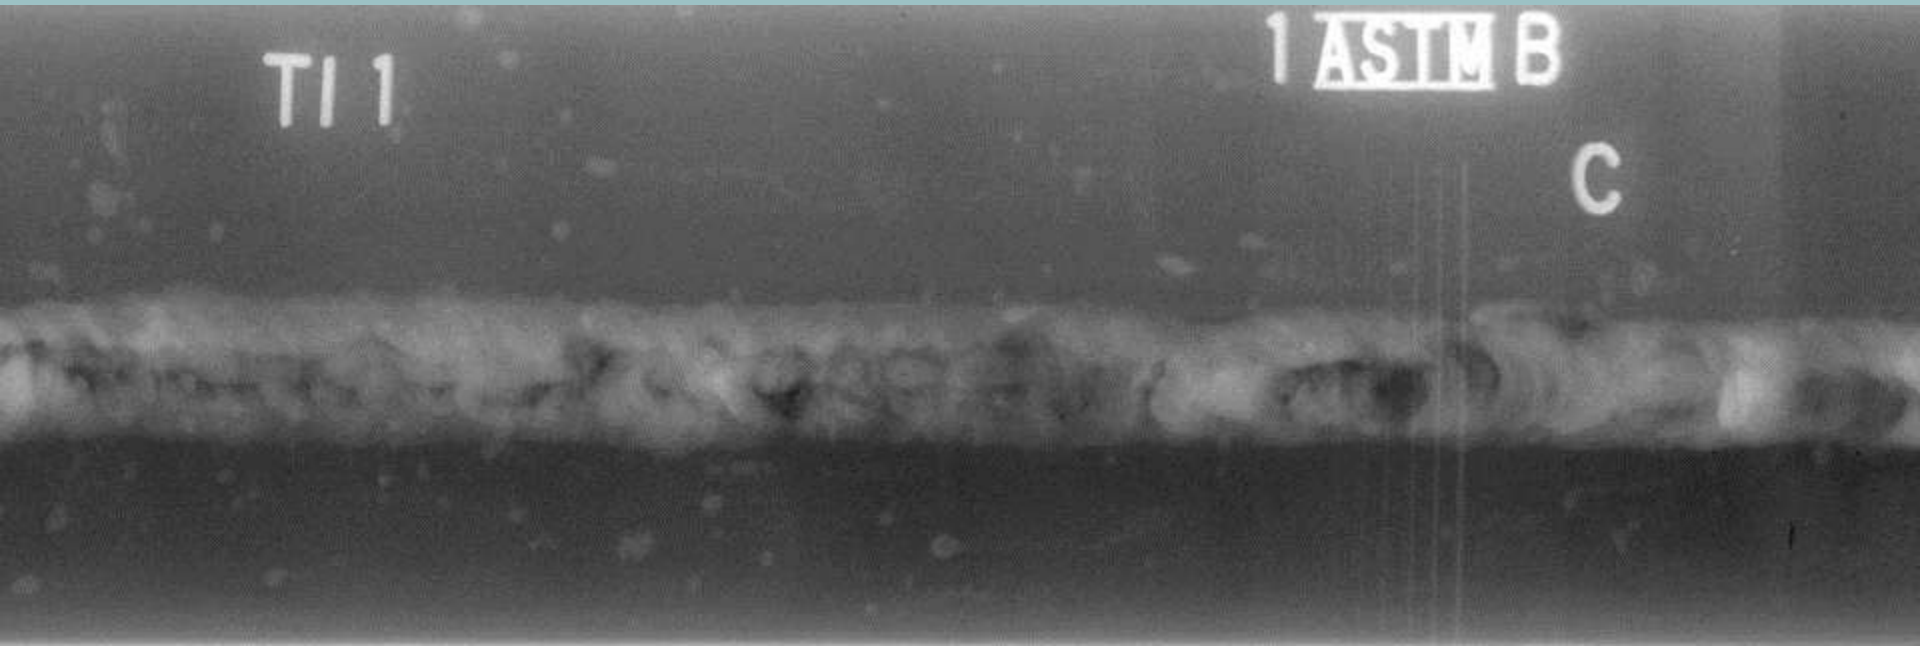
The complete outline of the essential wire must be visible and not obscured by number belt.

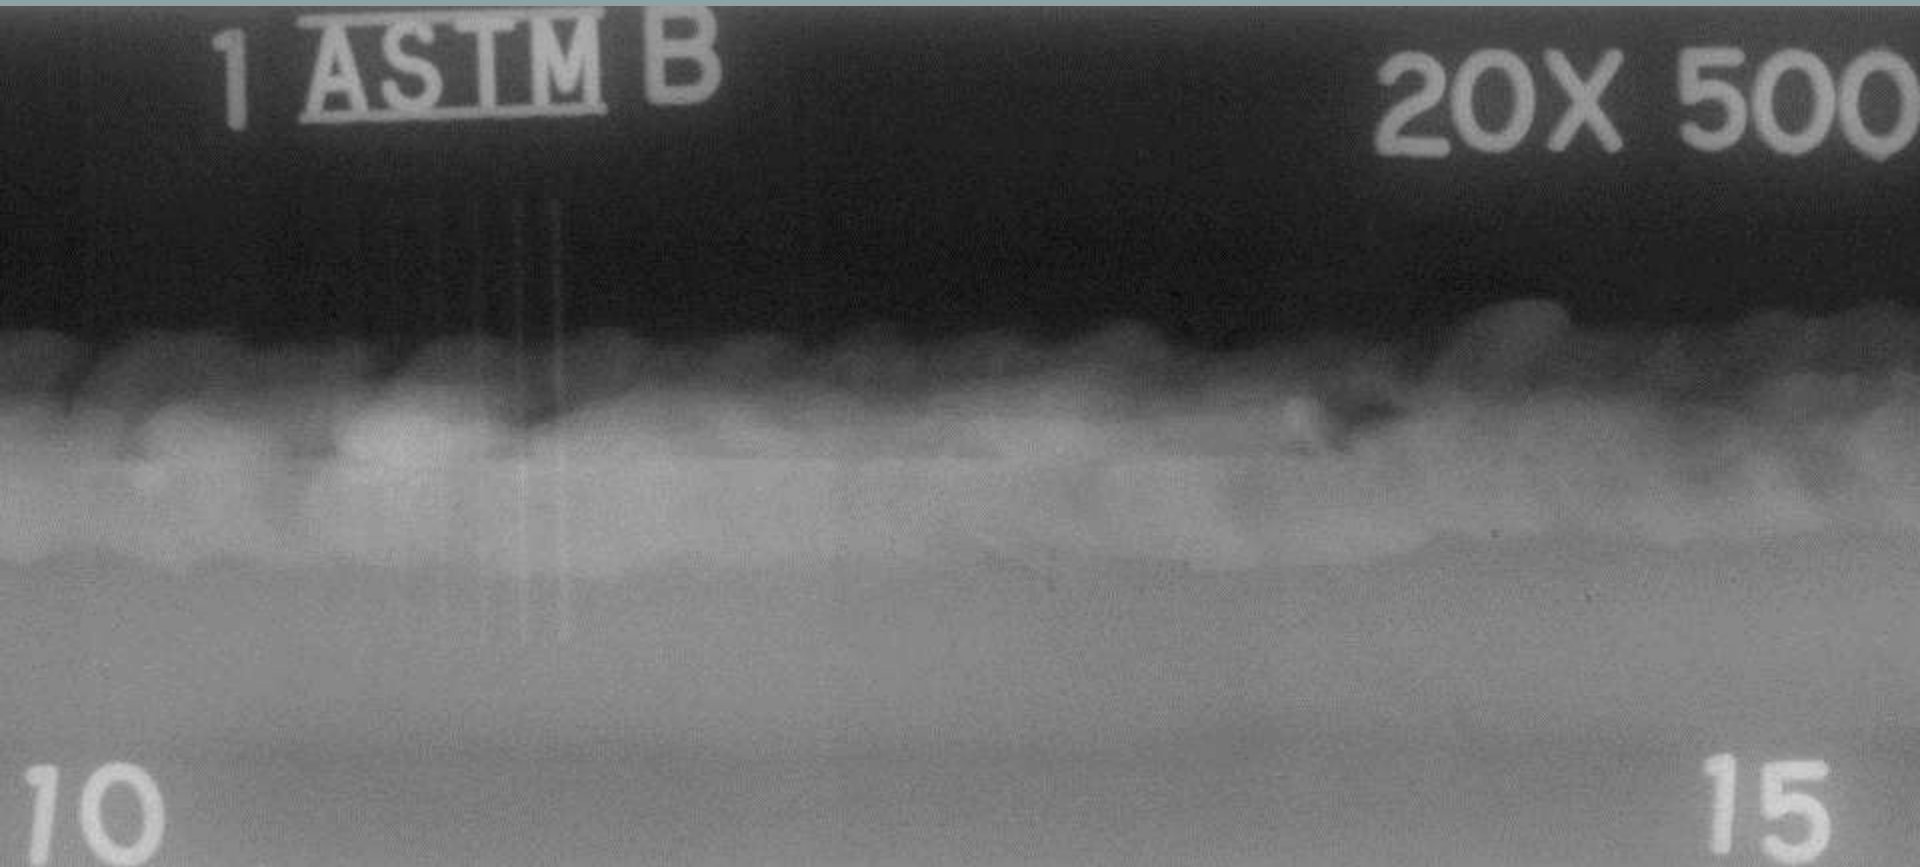
Is the radiographic density per API 1104 or operator's procedures?

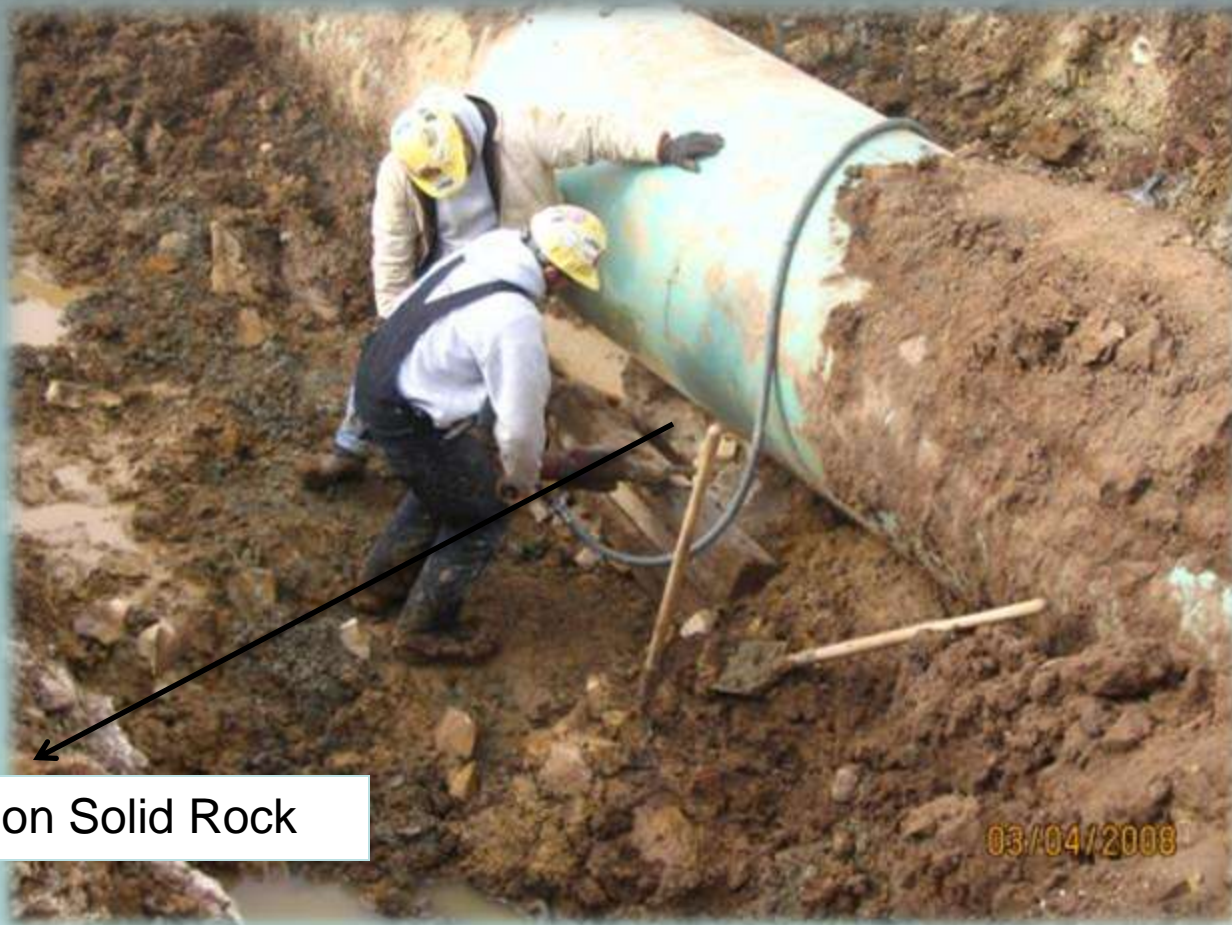
Anomaly Dig

Pipe on Solid Rock

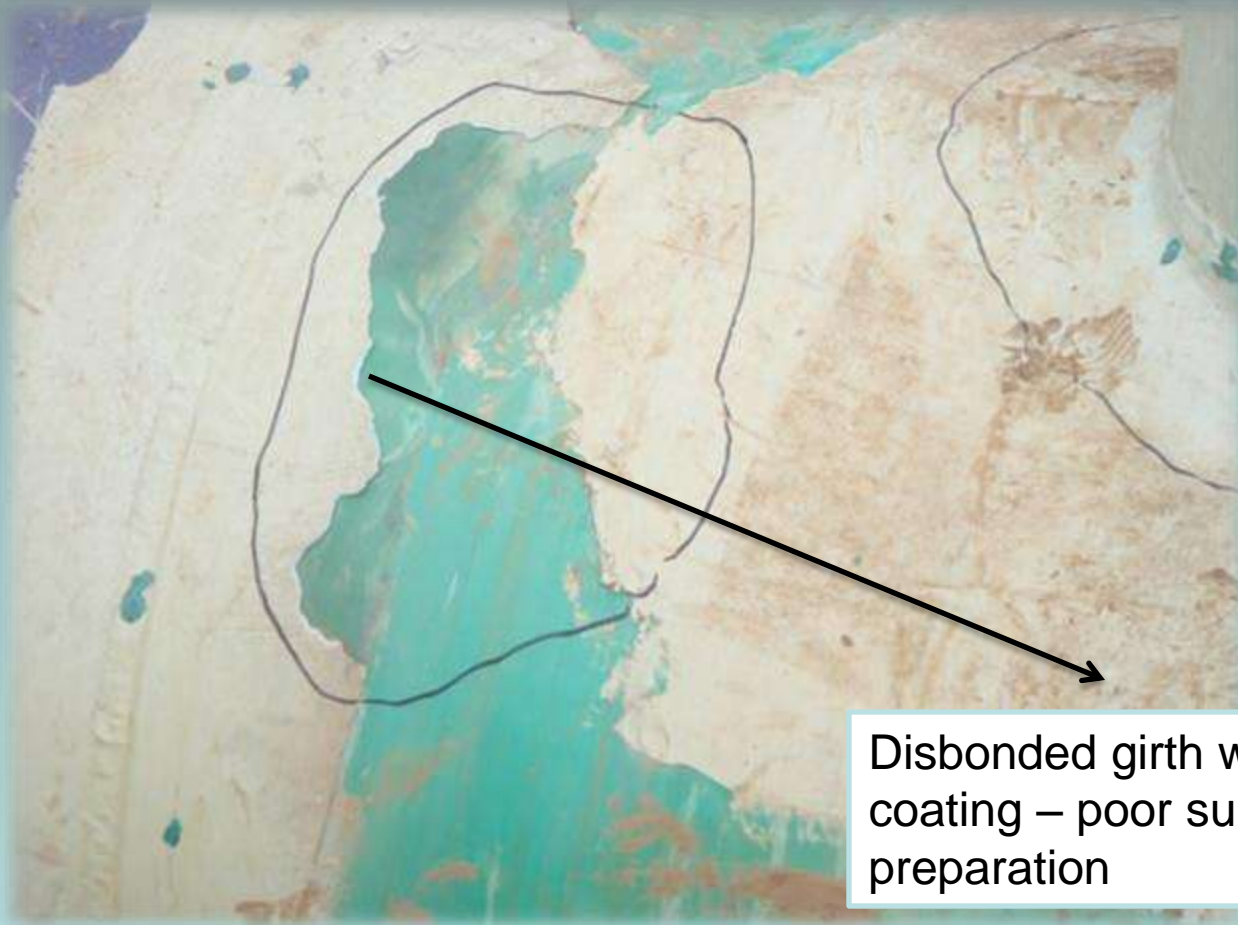
DCVG Dig on First Phase

Disbonded girth weld coating – poor surface preparation
